1959 PLYMOUTH BELVEDERE—
FROM PARTS CAR TO SHOW-
WINNING BEAUTY — **PART I**

Belvedere Beauty

*Thanks to the valiant effort of its owner, a fairly rare 1959 Plymouth Belvedere convertible gets saved from being parted out—
Part I: Disassembly and metal repair*

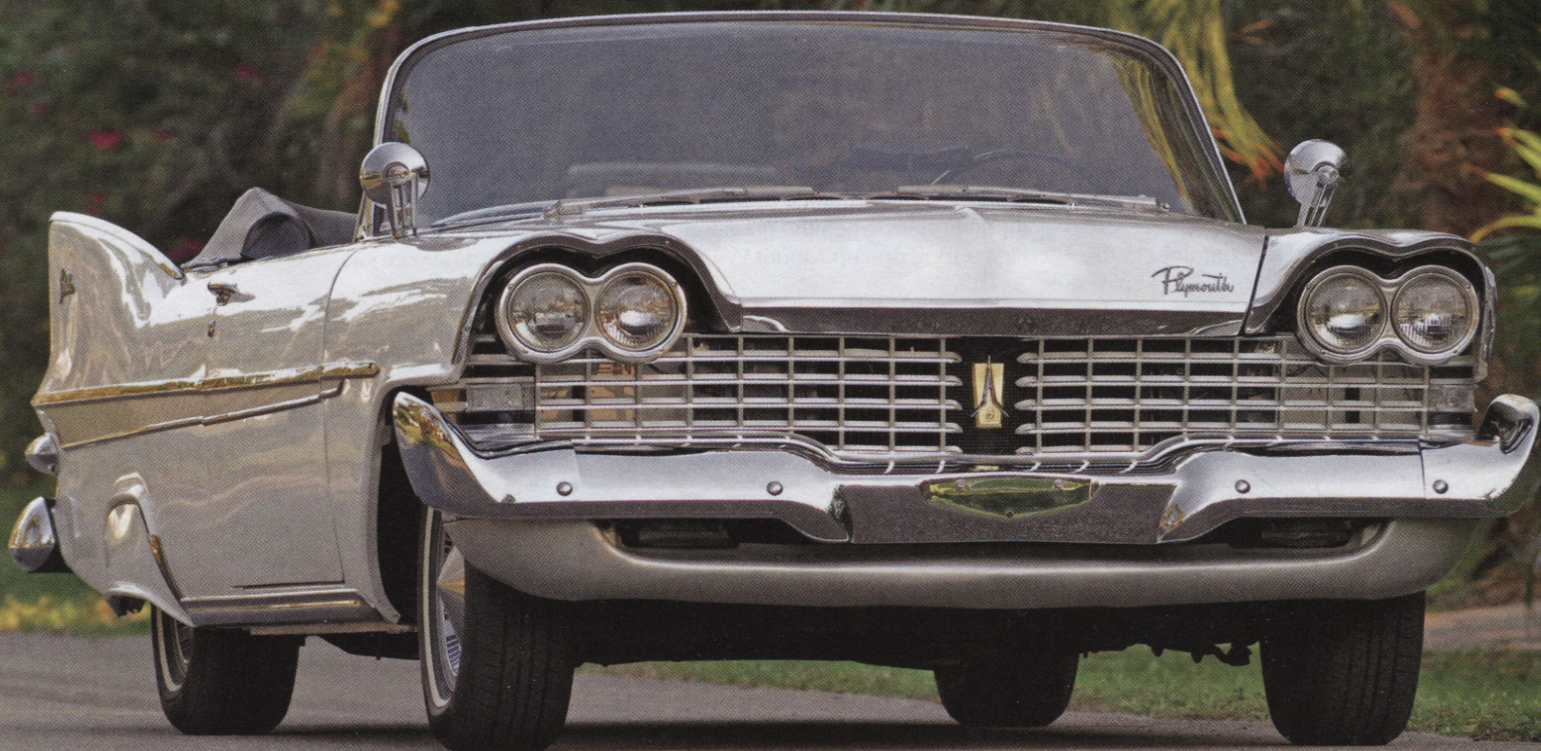
After Richard determined all that was needed to restore the Belvedere to concours condition, he removed the entire front clip. He then removed the heater assembly and every single component that remained on the firewall, as well as the doors and trunk lid.

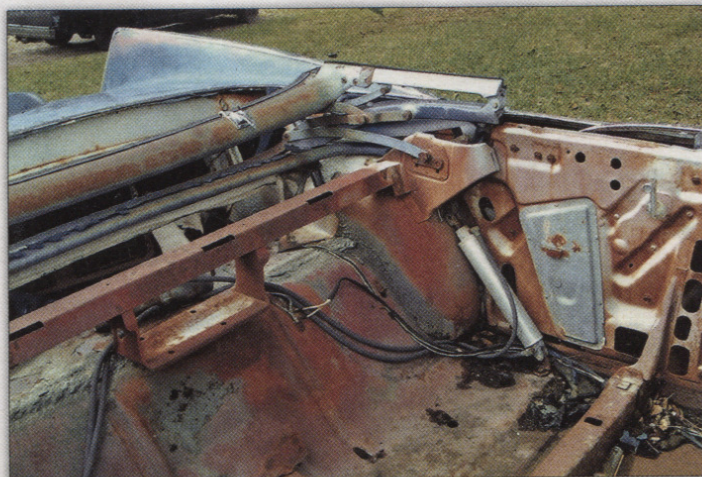
Although it looks bad, all the metal here was solid, and all the important and hard-to-find convertible top mechanisms were in place. But that was it; the rear seat was missing, as was the convertible top. A replacement rear seat was found in upstate New York.

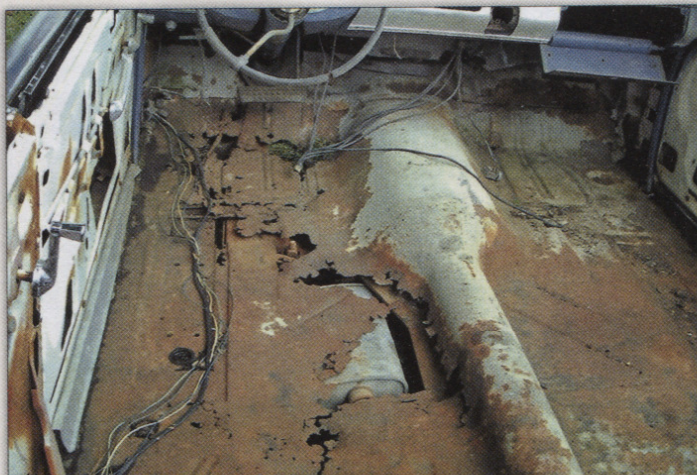
Due to sitting in a field for 37 years, without a convertible top to offer some protection from the elements, the floor pan rotted away—you can even see the frame rails below. New reproduction floor pans made of 20-gauge steel were MIG-welded in place.

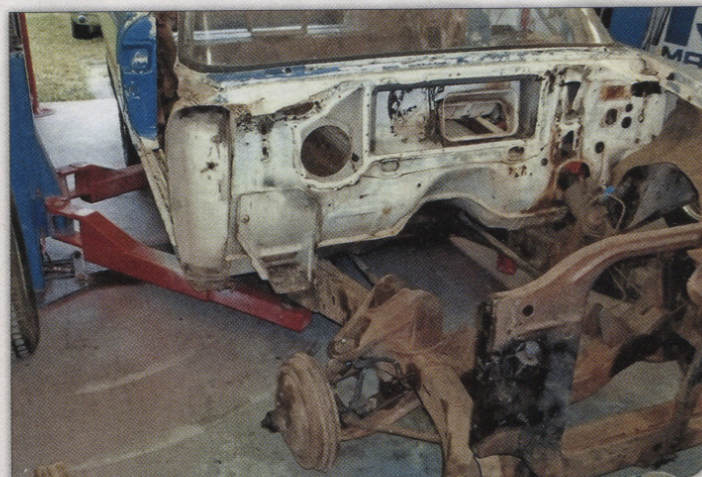
With the main body stripped of all its parts, it was lifted off the frame using Richard's two-post lift. Then the chassis was rolled out from below and into a portable tent "garage," where it was then painstakingly sandblasted down to bare metal.

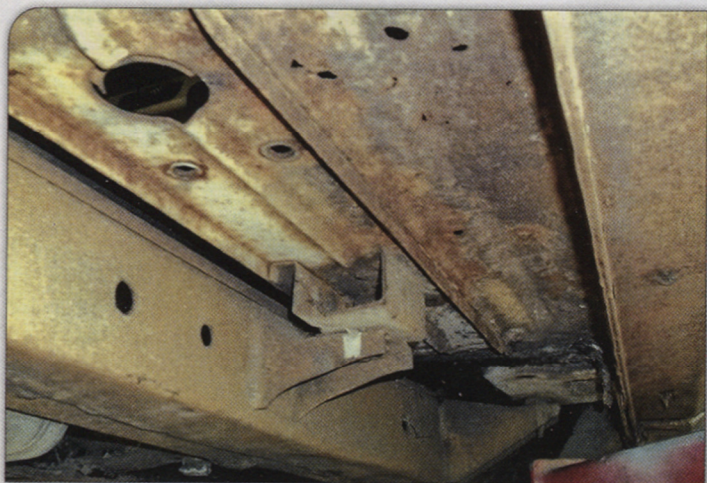
The entire undercarriage and every square inch of the frame was covered in a light layer of corrosion. Fortunately, the frame was straight and solid, without any holes to weaken the structure. It was only a matter of unbolting some 12 bolts to remove the body.

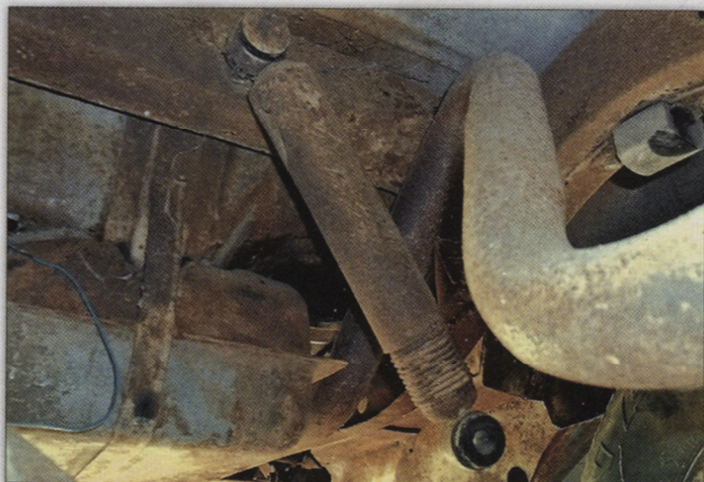
It wasn't important that the old shocks and exhaust system were covered in rust because they'd be replaced anyway. The original gas tank was dipped in a hot tank to remove the corrosion, then it was coated on the inside. Body metal appeared to be sound.

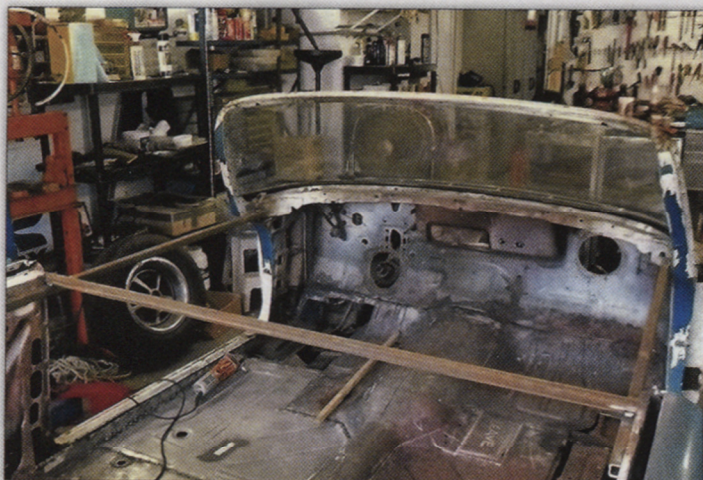
Before the corroded floor pans were removed, a solid metal brace was welded in between each door opening and the rear of the body to prevent it from twisting out of place. Note that the entire instrument panel and the wiring harness were also removed.

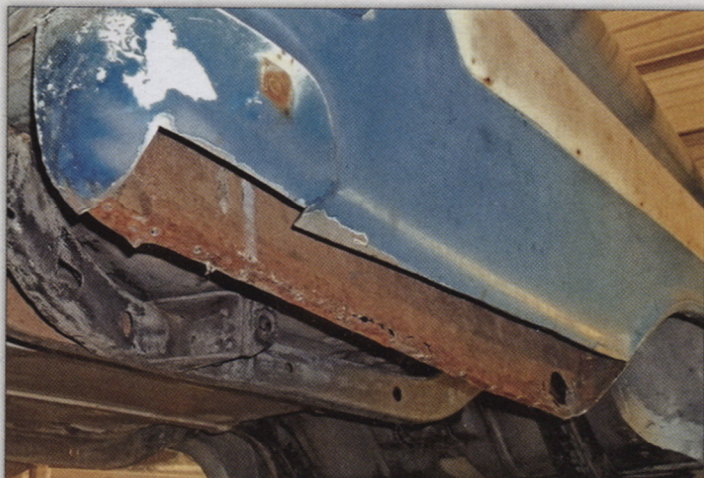
Even after nearly four decades of sitting outdoors, the body remained solid and relatively free of corrosion. The only area that rusted out was the entire bottom section of the quarter panel on the passenger side. Even the bumper brackets were solid.

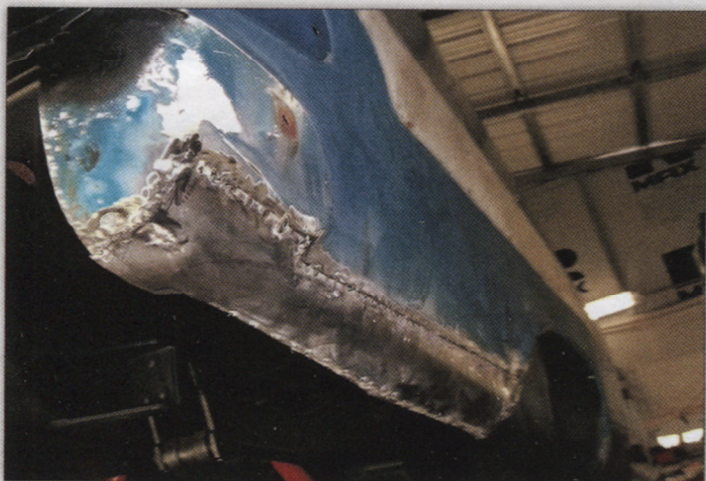
After the patch panel on the lower quarter panel was MIG-welded in place, the welds were ground down until they were smooth; this was followed by the application of a thin layer of lightweight body filler that was needed to fill in any low spots that remained.

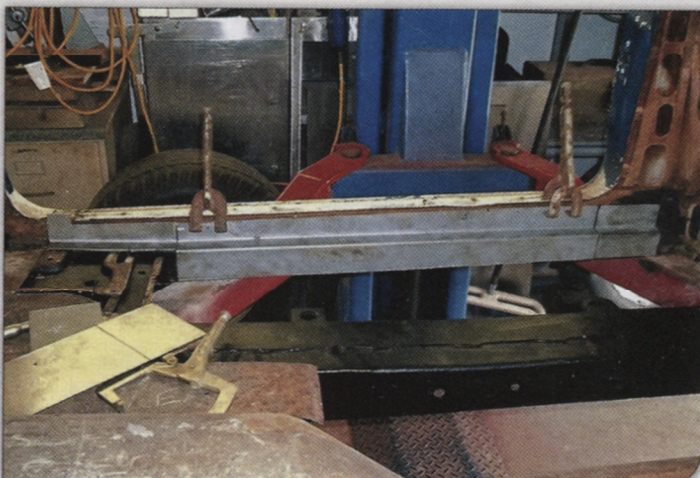
Before the floor pans were installed, new inner rocker panels were custom made of 18-gauge metal, and two welding-clamp Vise-Grips were used to firmly hold the rocker panel in place while it was being MIG-welded onto the surrounding door-opening frame.

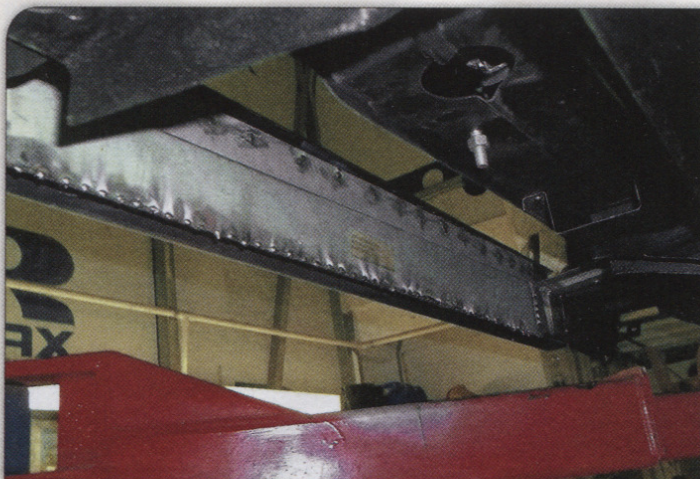
Welds spaced a half-inch apart provided the necessary rigidity to prevent the door opening from distorting. Each weld was then ground down smooth; then the entire panel was given a coat of Eastwood's Epoxy Encapsulator to prevent rust.

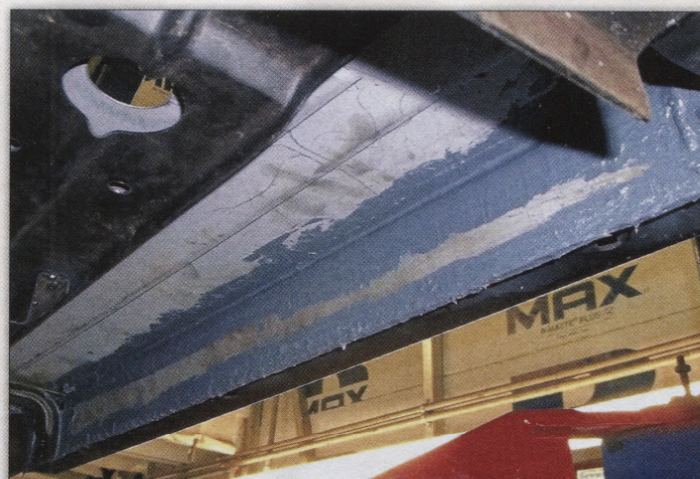
All the seams were given a thick layer of seam sealer to prevent moisture from seeping between the joints. Then two coats of Eastwood Epoxy Encapsulator coating was applied, which would then be sprayed over with several coats of black semi-gloss enamel.

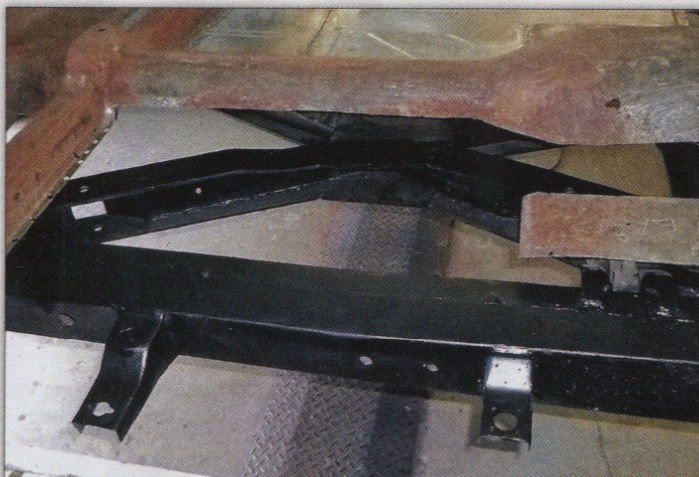
After the frame had been sandblasted, a layer of Ospho metal treatment was applied. This chemical transforms whatever rust remains into a tough surface, which then allows subsequent paint layers like the black semi-gloss enamel to bond solidly.

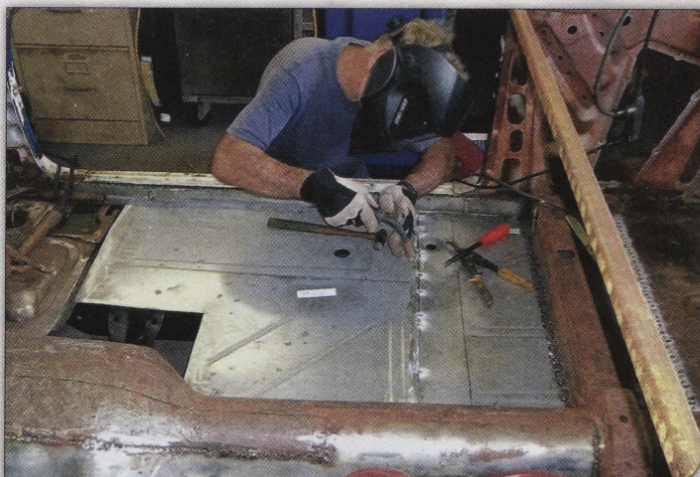
The body was temporarily placed atop the frame so the reproduction floor pans could be welded in. Twenty-gauge pans were made in sections, but once welded together, the floor became a solid panel. Welds were initially made every few inches, to prevent distortion.

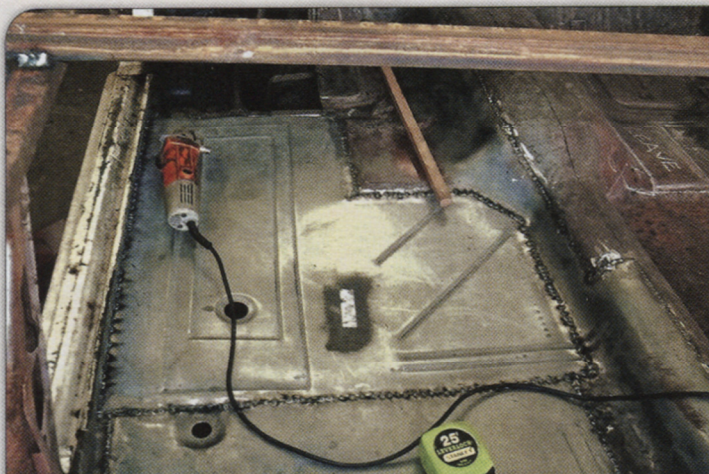
It took several days to complete the installation of the new floor pans. Then a grinder with 3-inch abrasive discs was used to smooth down all the welds prior to painting. Although not difficult, installing floor pans is very time consuming to do right.

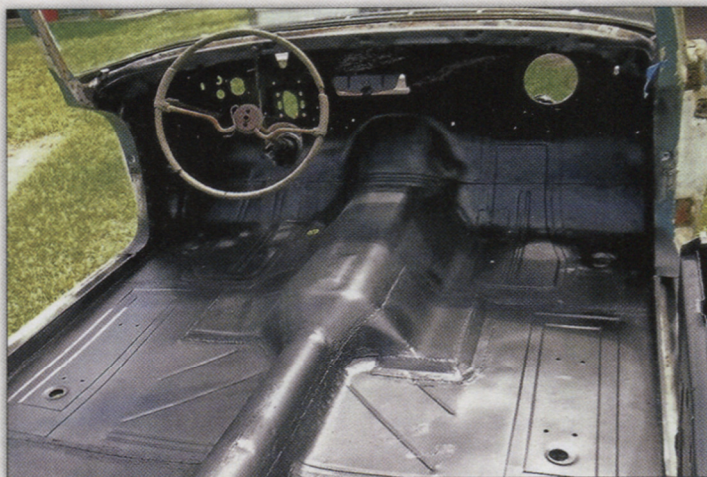
After the transmission tunnel, firewall and other original interior panels were coated with Ospho, new seam sealer was applied, followed by two coats of Eastwood's Epoxy Encapsulator. This was followed by two coats of semi-gloss black enamel.

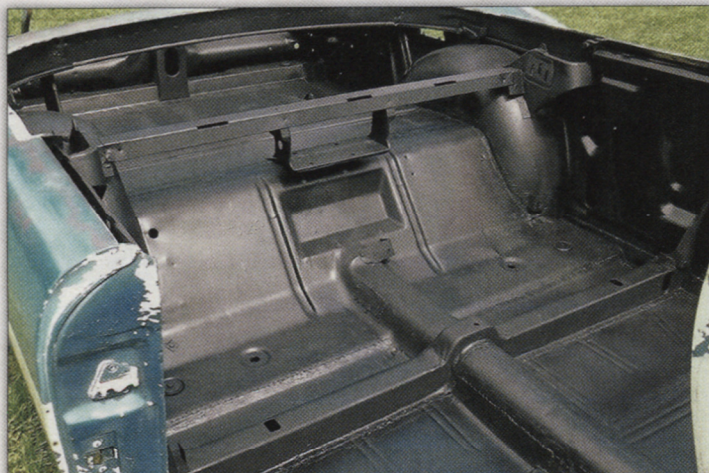
What a difference in how the rear interior body area looked after all the surface rust was removed and everything refinished compared to the way it looked on page 61. Lots of work was required to get to this stage, but the effort was clearly worth it.

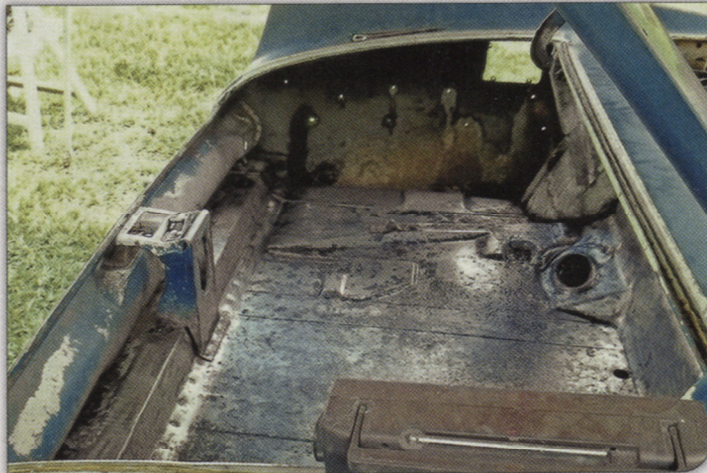
The original trunk floor was surprisingly solid, apart from one small area around the left side body mount. Using a 4-inch plastic wheel on a drill, the surface rust was removed before the floor was coated with Ospho phosphoric acid, seam-sealed and then epoxied.

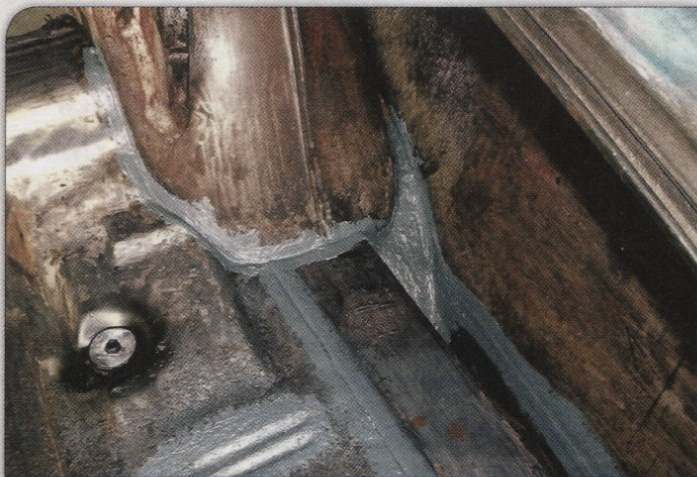
To prevent moisture from finding its way into the corners and between adjoining body panels, a thick application of 3M Seam Sealer was applied on every seam throughout the body. This was done after the metal was coated with Ospho, and before the epoxy.

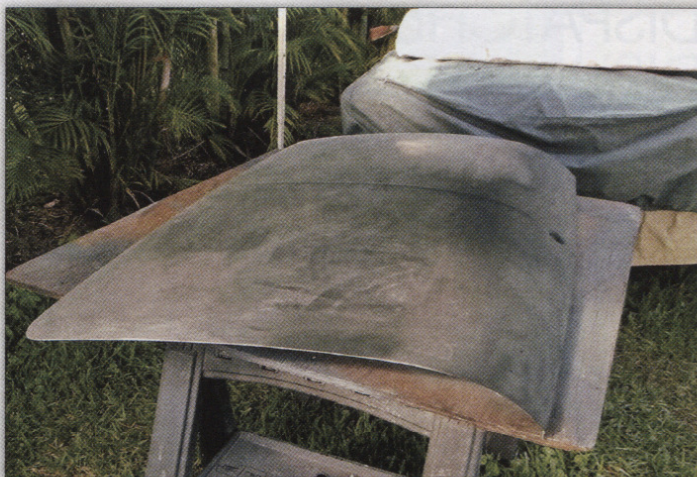
All the removable body panels were placed on wooden horses outdoors and had aircraft paint stripper applied to remove their existing finish. After two applications of stripper, a 3-inch nylon wheel on a drill was used to get down to clean, shiny metal.

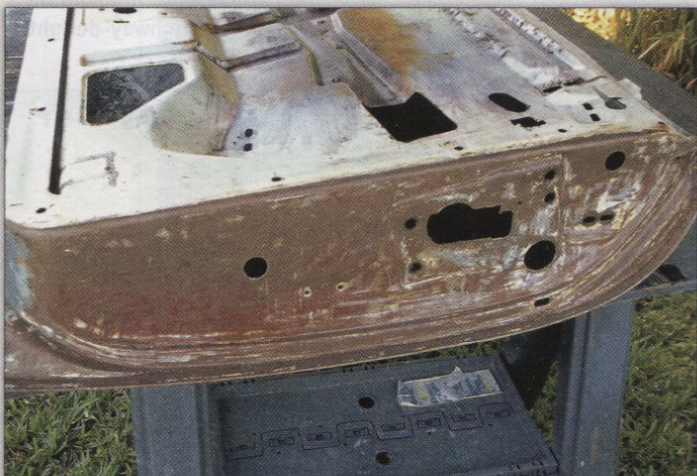
Both doors were solid, with just light surface rust present. After paint stripper removed all the existing topcoats, a nylon wheel was used to get down to bare metal. The nylon wheel doesn't scratch the metal, and gets into all the small crevices.

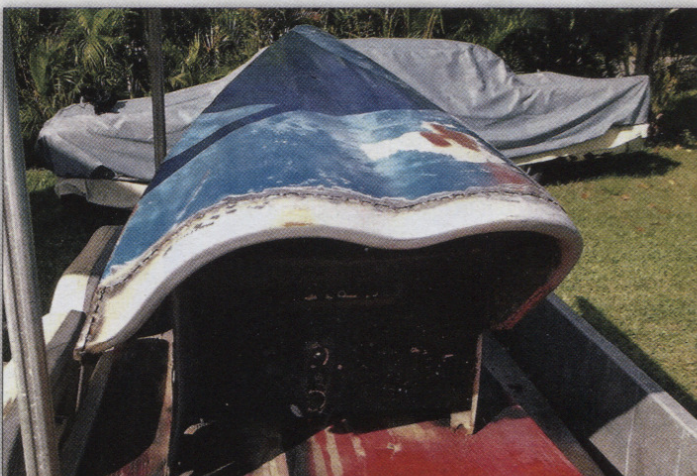
The leading edge of the 1959 Plymouth's "floating headlamps" fenders are a known rust trap, and these fenders were no exception. Replacement double-barrel patch panels were grafted on. Stainless steel molding then goes over the leading edge of the fender.

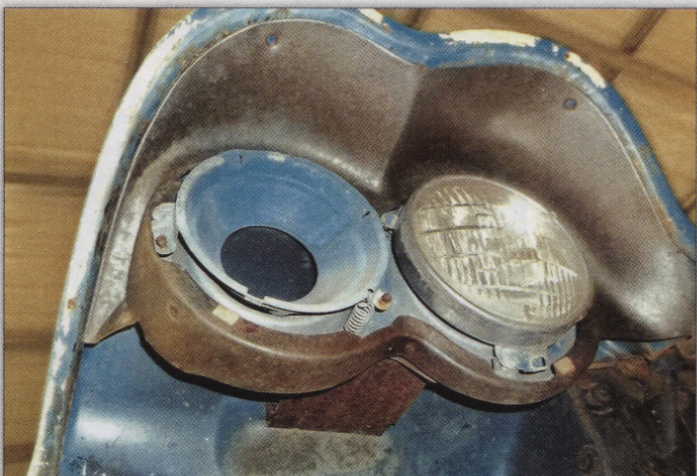
This passenger-side front fender shows the twin headlamp assembly in place before it was removed to patch the top side of the fender's leading edge. Then this assembly was bead blasted down to bare metal before being refinished in flat black as original.

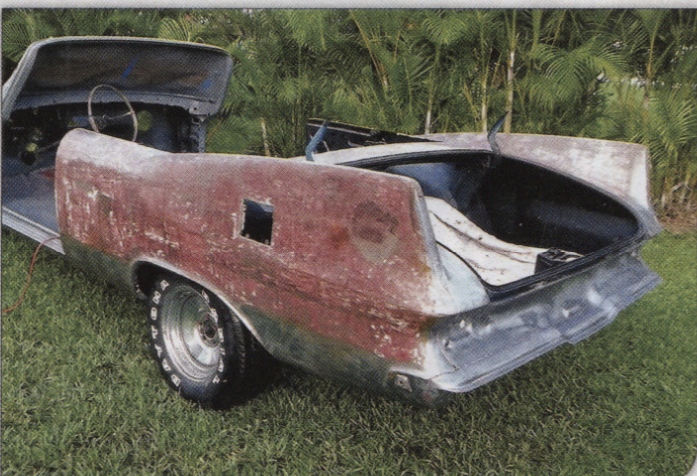
The rest of the body was solid and free of any rust or accident damage. These quarter panels are huge, and each took an entire day to strip down to bare metal. After a thin coating of lightweight body filler was applied, they were block sanded smooth.
